Compromising the IC_204 ECU

Flashing arbitrary, unsigned firmware

JinGen Lim

June 2021

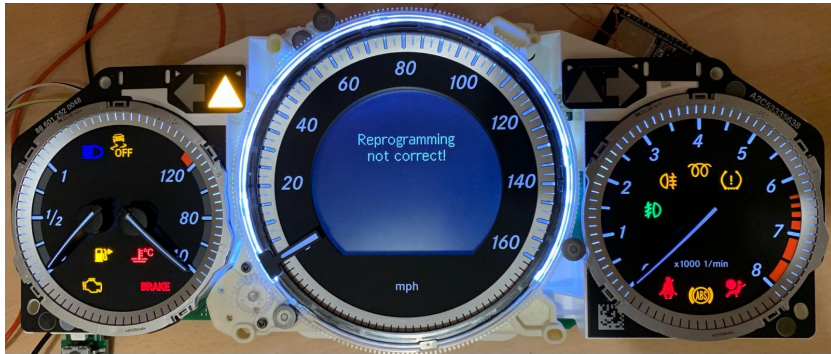
These flags are only written after clearing a signature check in the final stage of the flash process, after the firmware verification routine is completed. The absence of this flag indicates a failed or interrupted flash process, or an invalid firmware checksum. In such a situation, the ECU will fail to boot normally.

As an example, when the verification flag is invalid for the DATA section only, the ECU will behave normally on the CAN bus and is capable of entering an extended session. However, the LCD will only show a visual error such as "Reprogramming not correct!". For failure in more critical stages, the ECU will remain in a DFU mode (Boot_Variante), which responds to a minimum command set that is required to flash a working firmware.

Figure 3: Data verification error on the IC204

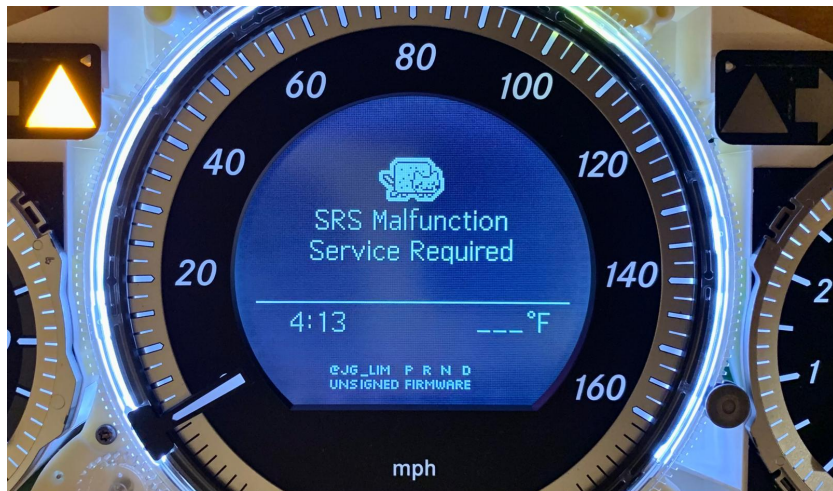
Due to an implementation flaw, it is possible to write the firmware verification flag directly onto the flash and completely bypass the verification routine, as write attempts to sensitive memory regions are not adequately checked during the flash process.

Figure 5: Successfully running unsigned firmware on the IC204

As a proof-of-concept, a modified flash file has been prepared and flashed into a vulnerable IC204 with the above technique. To demonstrate execution of modified code, authentication for security levels 5 and 7 have been altered to accept any key [Figure 6]. With this privilege escalation, the external EEPROM can be accessed with read and write capabilities. Some bitmaps for fault warnings and gear state have also been replaced to differentiate itself as an unsigned firmware. [Figure 5].

The flash loader should be updated to track and reject write attempts into sensitive memory regions such as the verification flags. This may be applied through a future firmware update.

The signature checking strategy can be improved with an additional check at flash time, to ensure that the verification addresses are protected. MB/VDO may also wish to review other ECUs of similar architecture to check for the presence of this class of vulnerabilities.

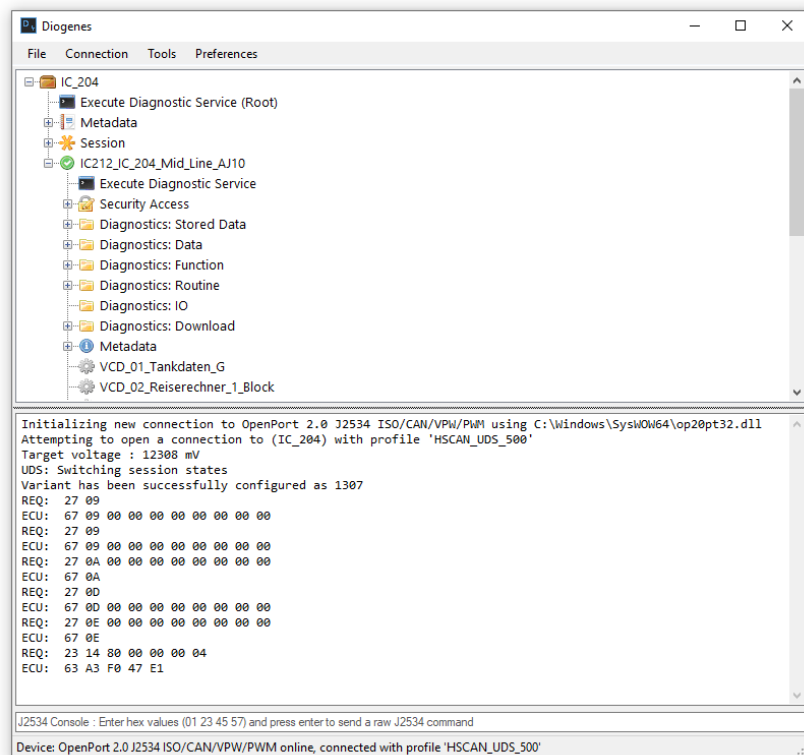
- Compromise of update mechanism
(Flashing an ECU with arbitrary firmware)⁴
- Broken Authentication
(PoC: security level 7, maximum for IC204)
- Unlocking/Modifying vehicle functions

Figure 6: Privilege escalation to level 7 and reading the onboard EEPROM
