# 1990 - CID510160\_TazewellCounty\_CFPF-6

| Funding Opportunity: | 1446-Virginia Community Flood Preparedness Fund - Capacity Building/Planning Grants - CY23 Round 4 |

Cumberland Plateau Planning District Commission  
Hazard Mitigation Plan

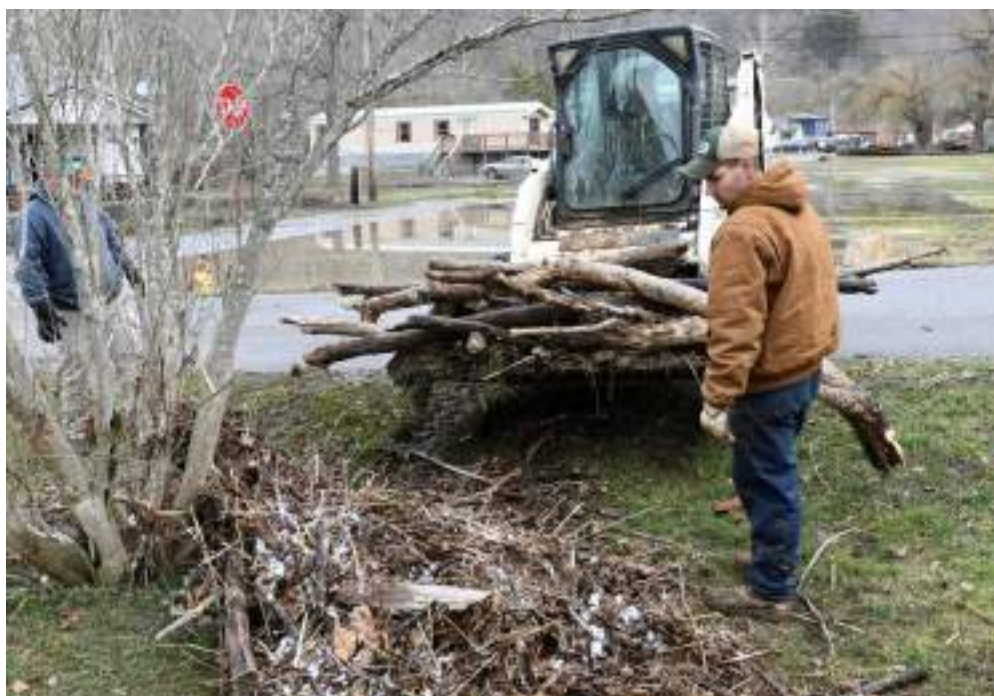
Natural debris, such as woody vegetation and sediment from erosion, can also restrict the natural capacity of the stream (e.g., sediment building up on the streambed) and contribute to flooding. Natural debris left by a flooding in Richlands flowing a 2020 event is shown in Figure 614. When not cleared, especially after a flood event where areas pile up with debris, a hazard is created as the stream is essentially dammed and increases the likelihood that a rainfall event will become a major flood event.

*Figure 614: Flood Debris from February 2020 flooding in Richlands, VA<sup>23</sup>*

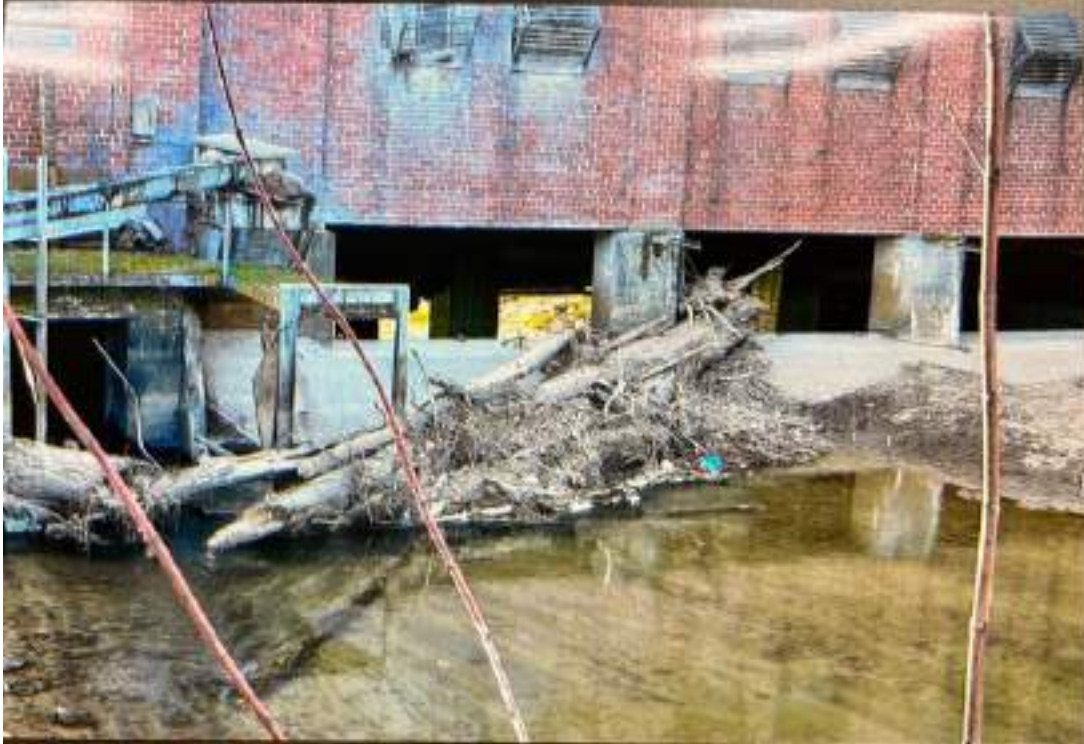
*Figure 642: Debris Gathered on Upstream Side of Abandoned Mill Building in North Tazewell*

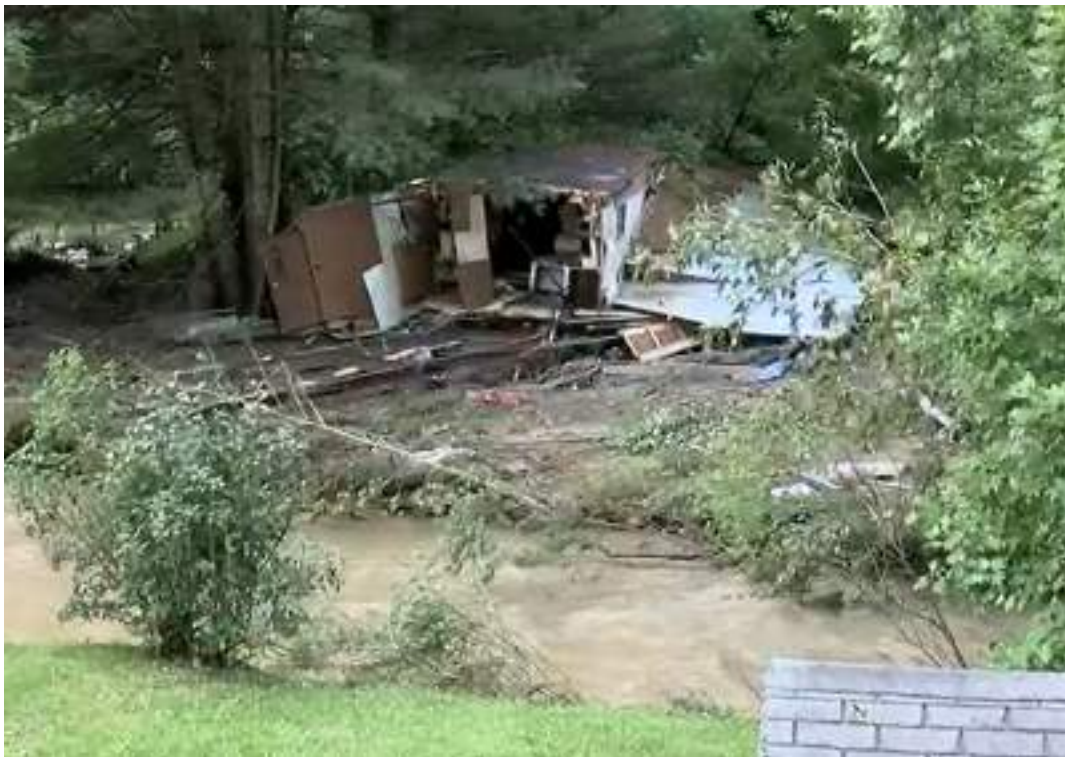
*Figure 644: Mobile Home that was Destroyed during the July 2022 Flood Event in Bandy, VA<sup>51</sup>*

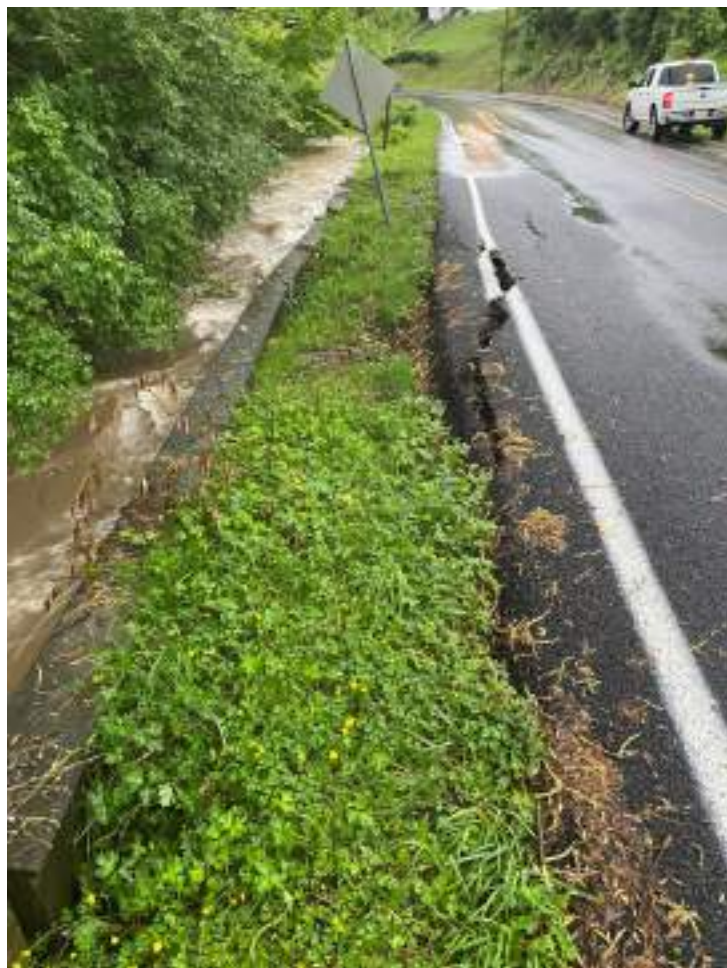
Figure 645: Road Damage in Bluefield, VA from Flooding in March 2023

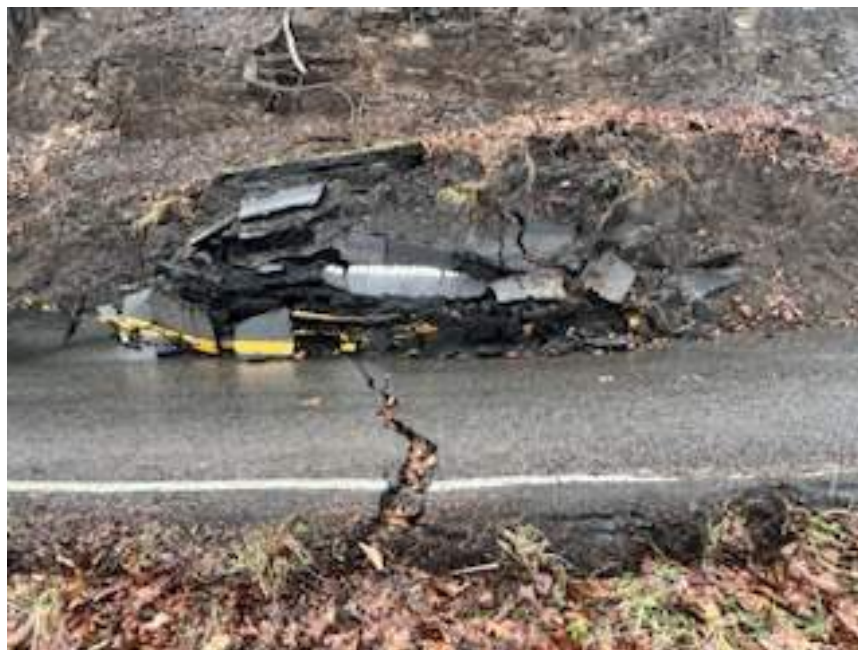
*Figure 647: Damage from Landslide Event on Route 91*

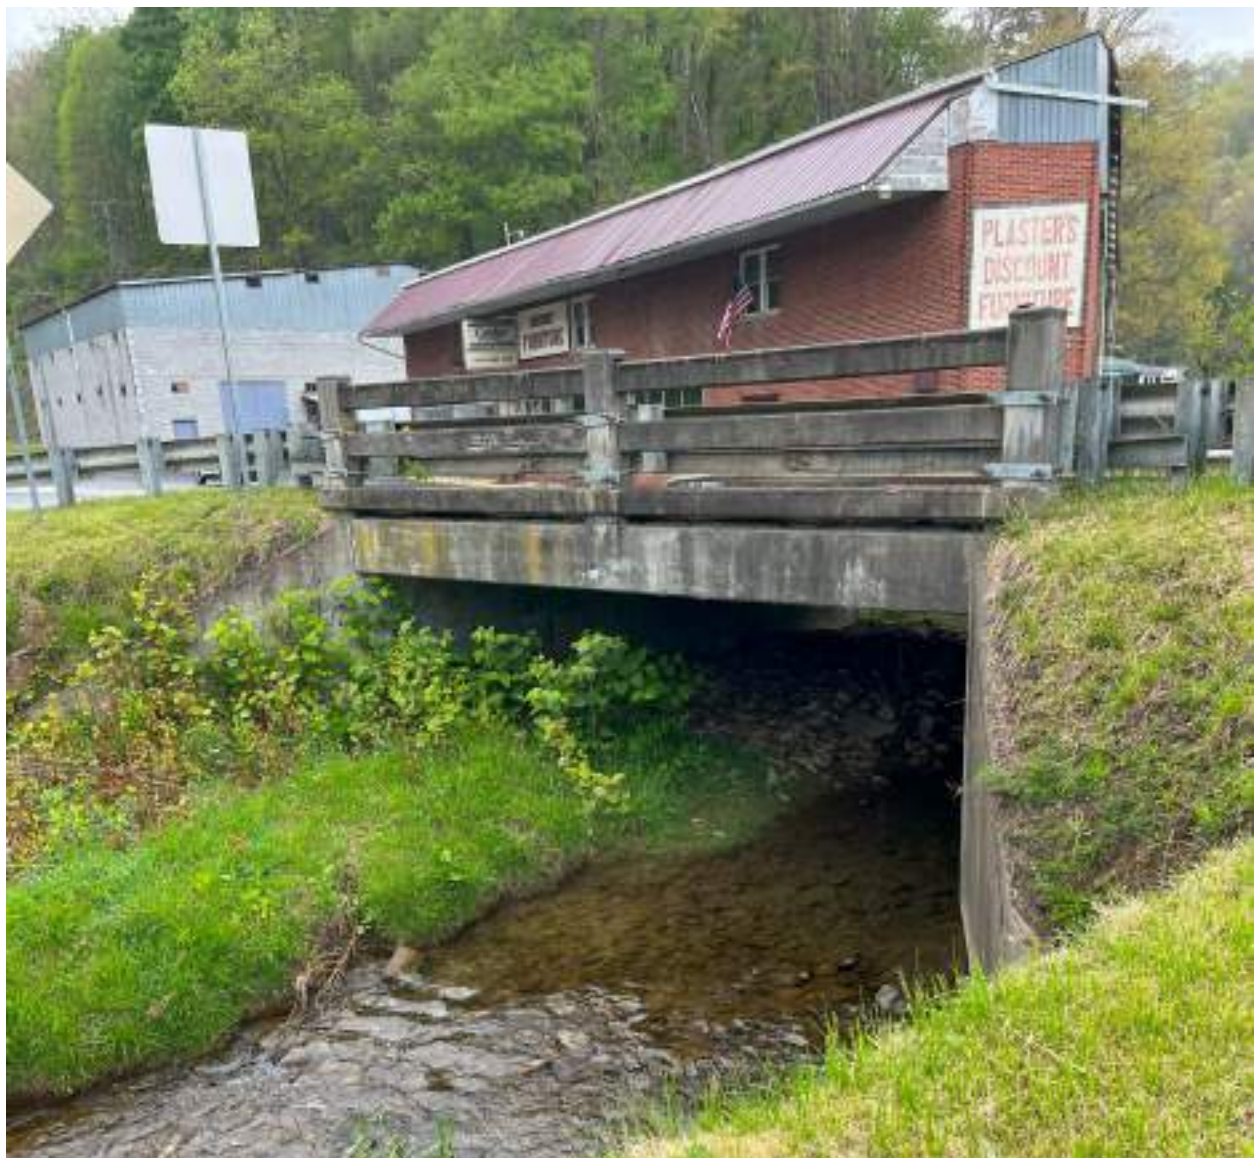
*Figure 727: Culvert crossing Mill Creek*

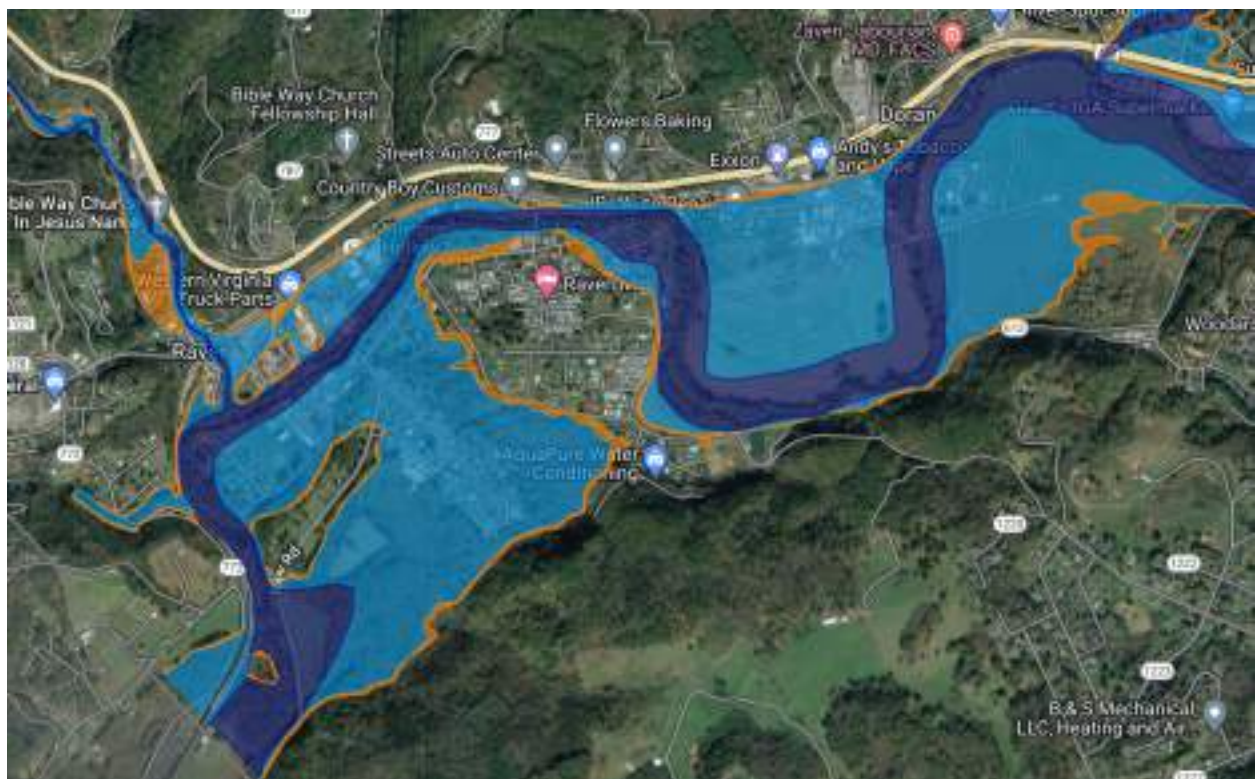
Figure 729: Traditional 1D Modeling

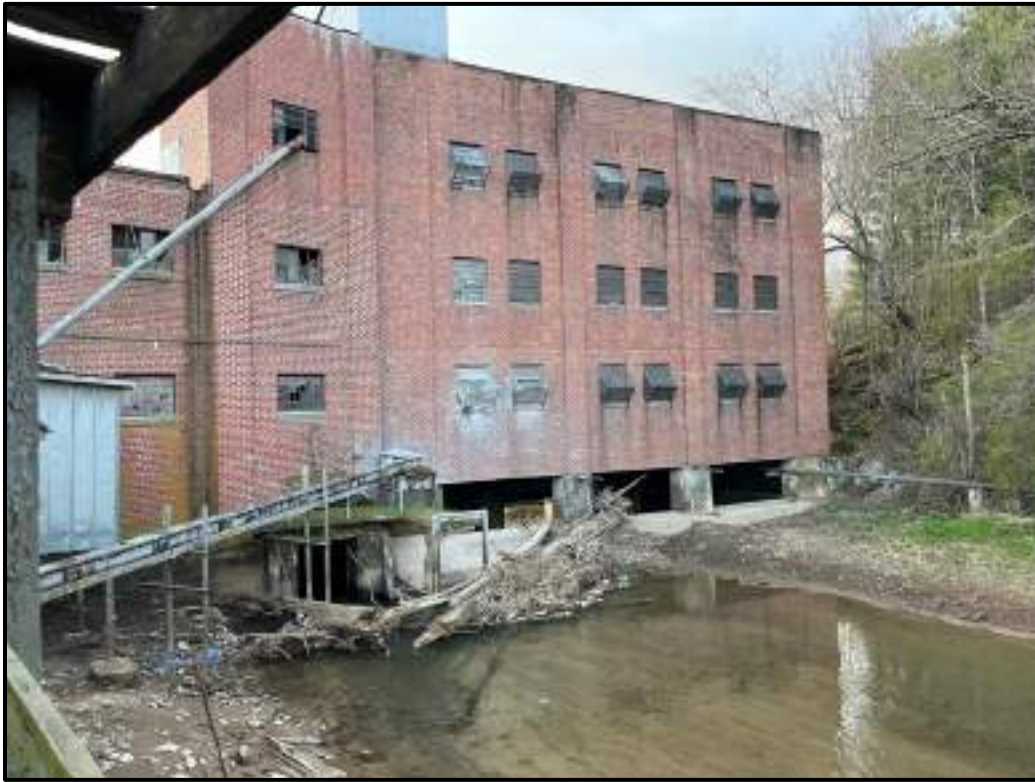
*Figure 71: Mill Building March 2023 capturing debris*
