Compromising the IC_204 ECU

Flashing arbitrary, unsigned firmware

JinGen Lim

June 2021

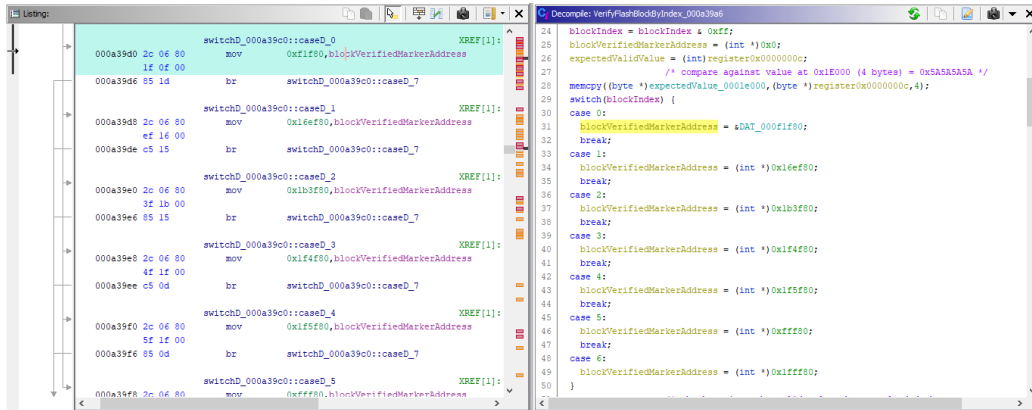
For this specific IC204 ECU/firmware, there are 7 logical blocks that require a valid verification value; should this value be empty or incorrect, the ECU will refuse to boot normally. These values are always erased when starting the flash process, and are written only after a successful verification routine.
